RF Progress at Diamond Light Source

Pengda Gu and Peter Marten
For DLS RF Group

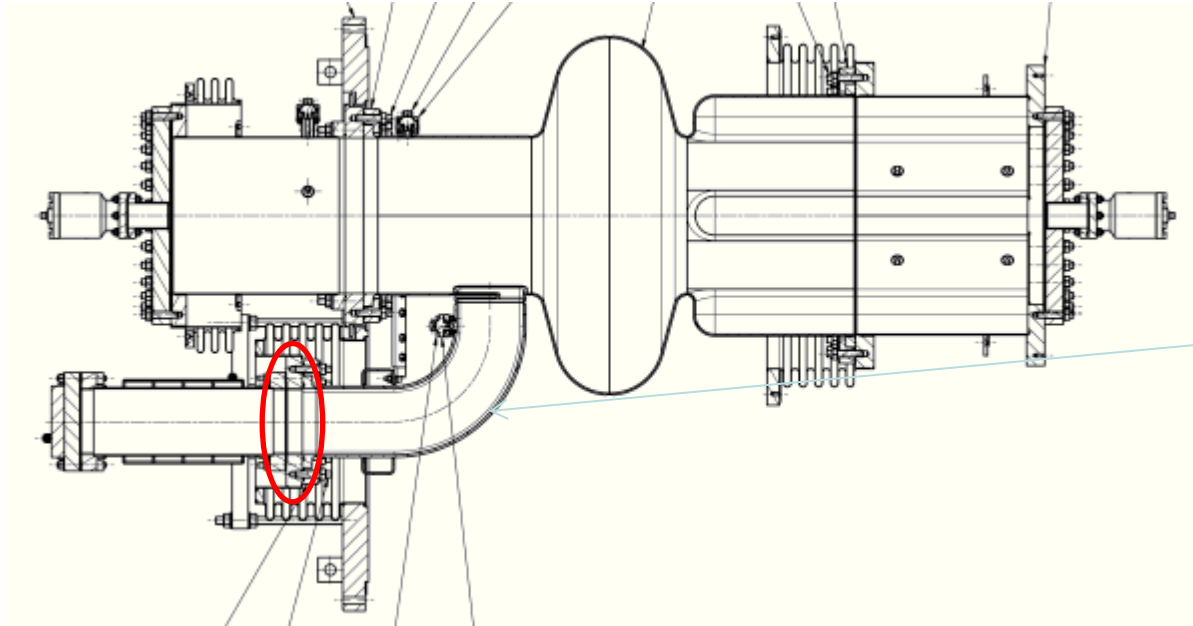
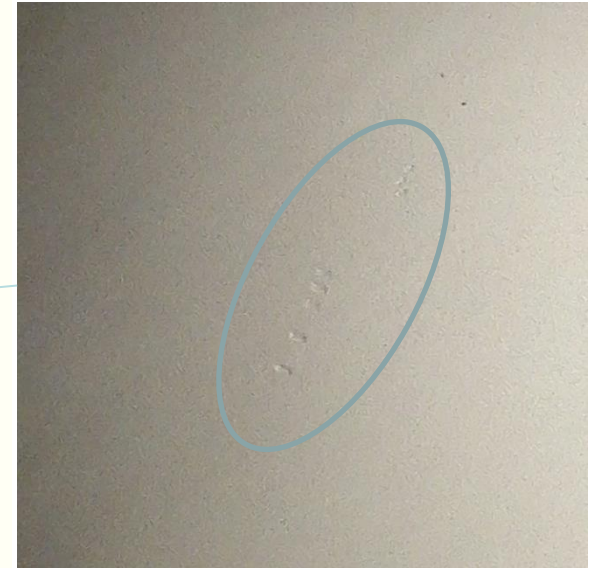
Investigation at RI

Leak rate $2 \times 10^{-8} \text{mbar} \cdot \text{l/s}$

Repair and modification plan:

Add AB sensor along niobium waveguide bend.

Add TSPs with isolation valve on RBT side.

Modify helium fill tube to achieve more uniform cooling.

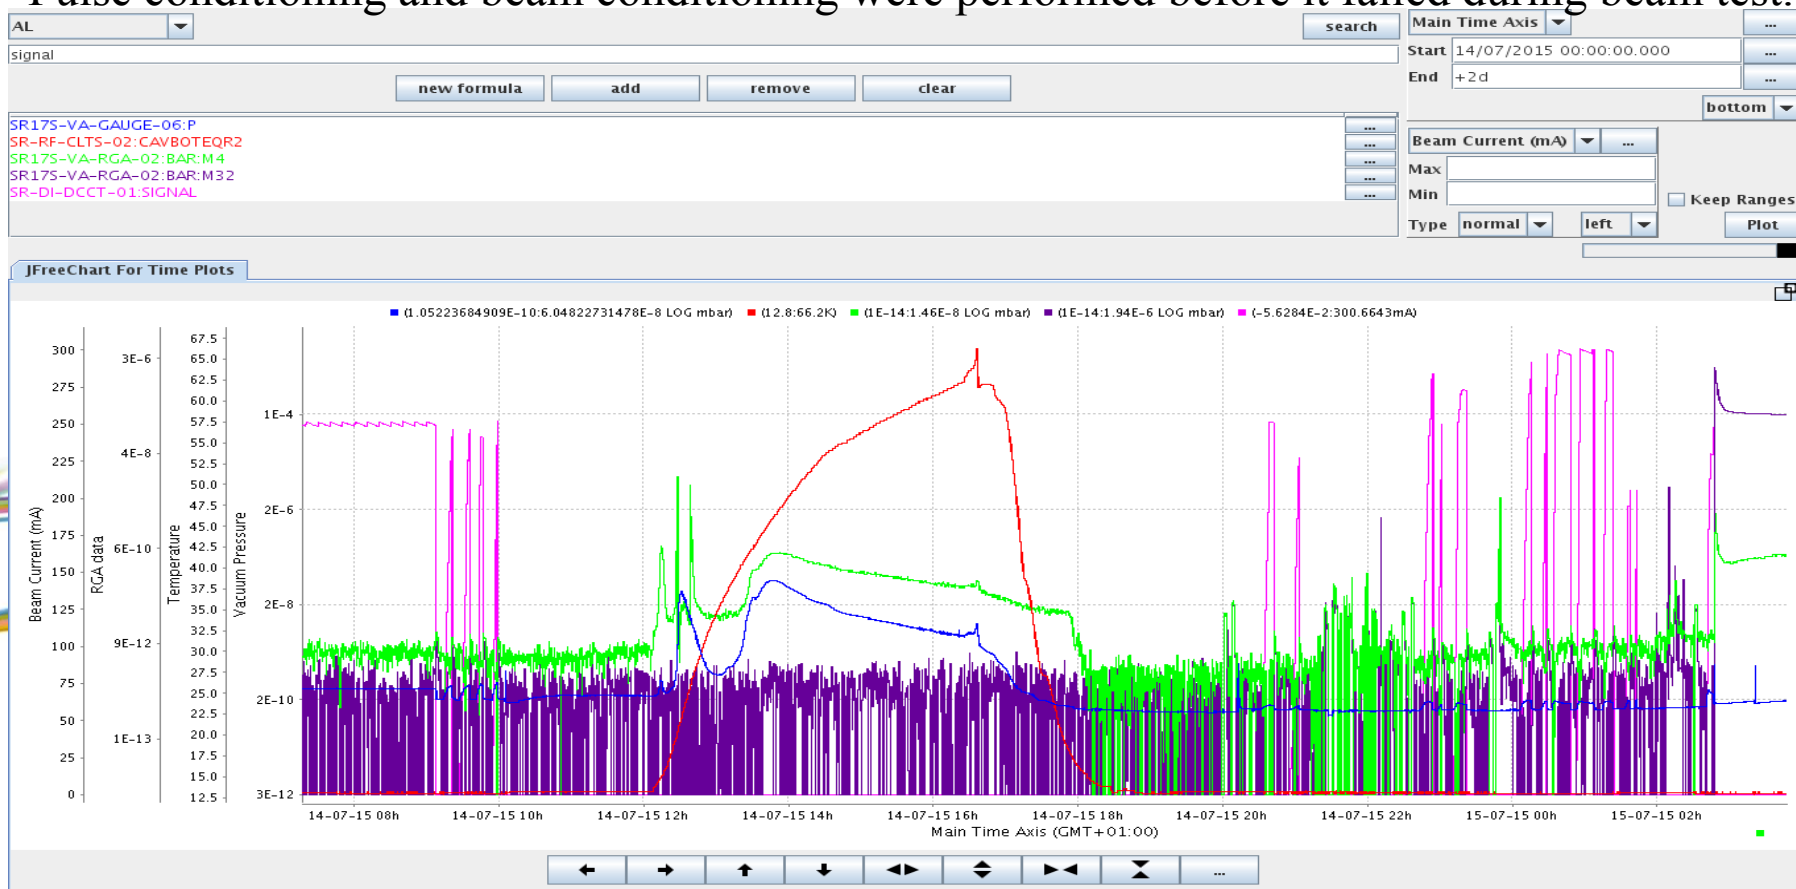
Cavity 4 RF Window Leak

Cavity 4 was rushed through the FAT to replace cavity 2 last September.

It suffered many fast vacuum trips from the start.

Qext was pushed very low to 9×10^4 by using stub 1&3 of the 3-stub tuner.

Stronger and more lasting out gas even at low power level when both stub 1&3 were pushed in.

Recurrent trips on pump out box vacuum limited beam current to 250mA.

Pulse conditioning and beam conditioning were performed before it failed during beam test.

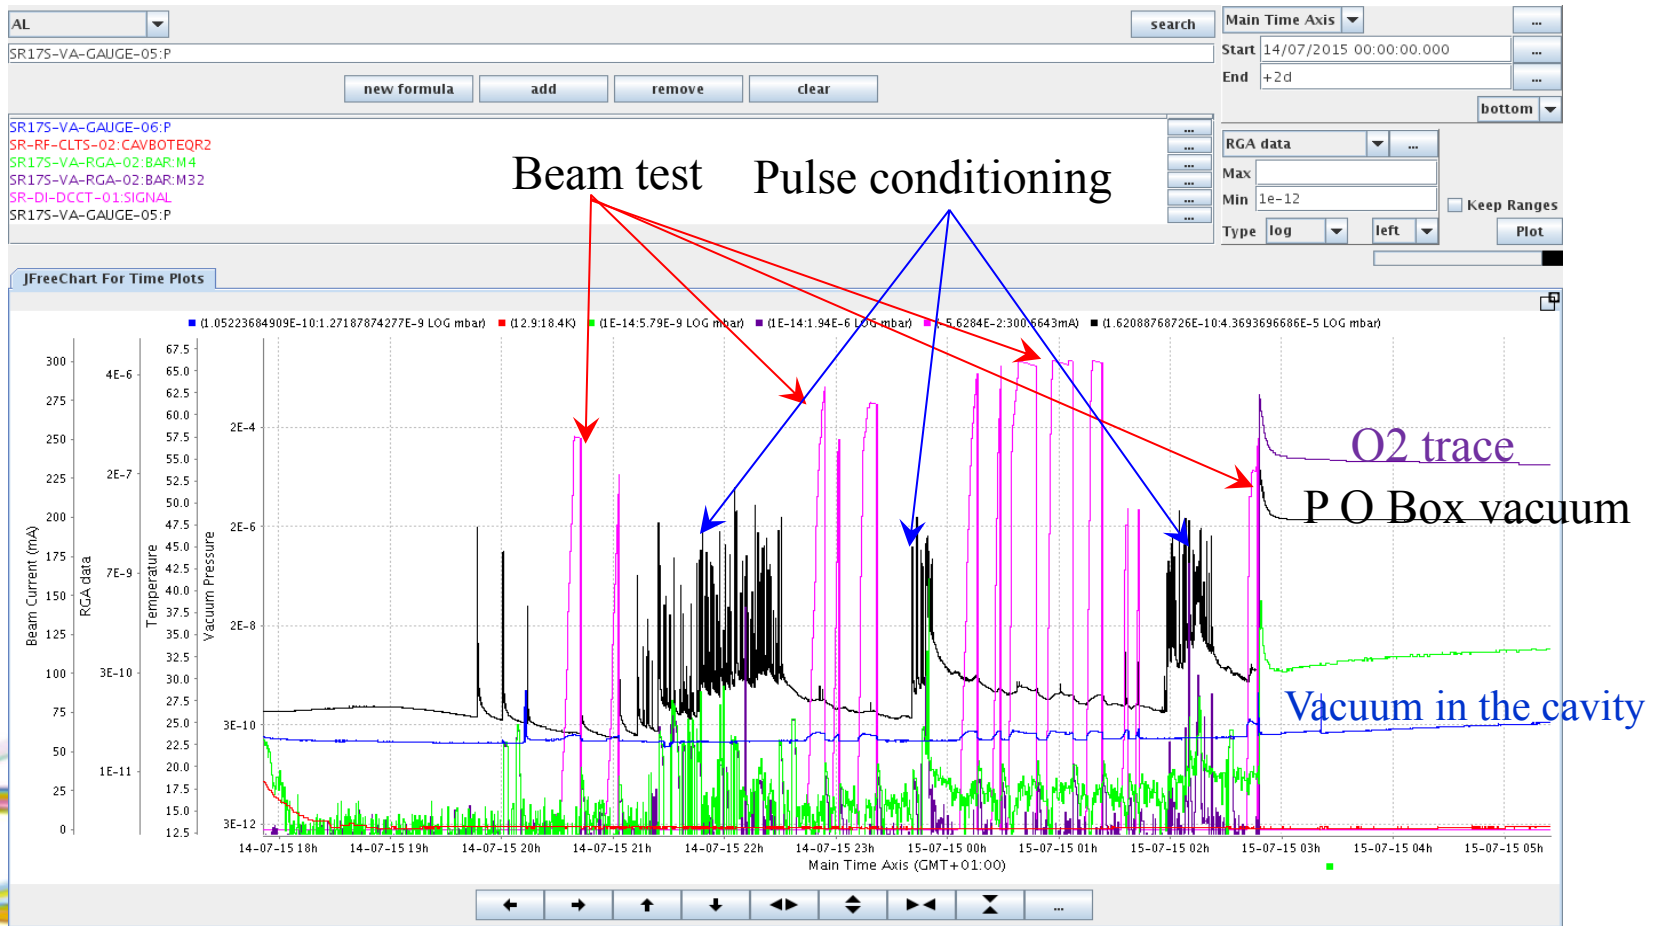
Cavity 4 RF Window Leak

Vacuum at valve box went up to 10^{-5} mbar at pump out box.
No big change inside the cavity.

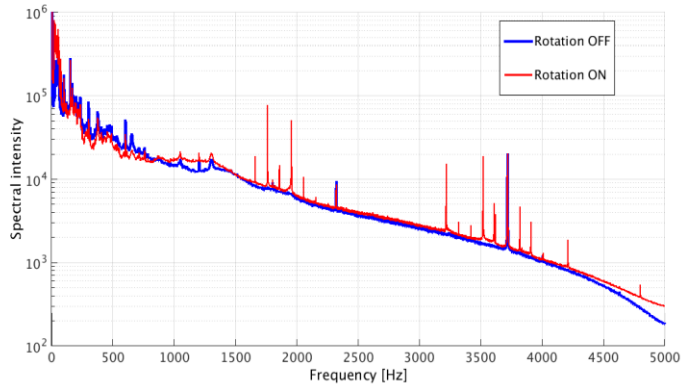
Elimination of high frequency noise

- HVPS module rotation is visible on the beam
- Infrared beamlines claim this pollutes their spectra

- Rotation lines can be removed
- Only remaining lines are mechanical vibration
- Vibration lines eliminated by water flow control

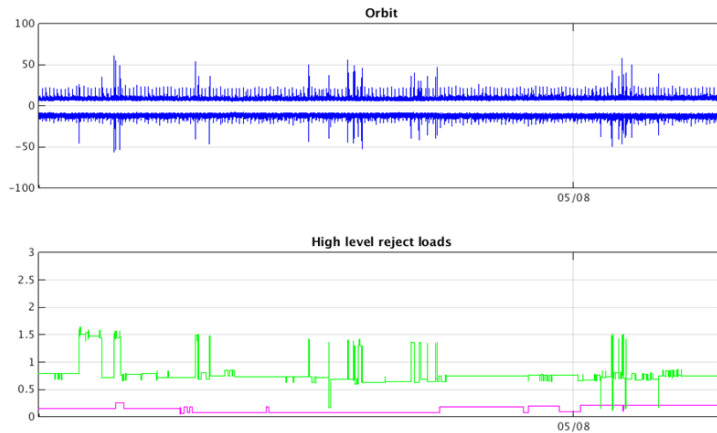
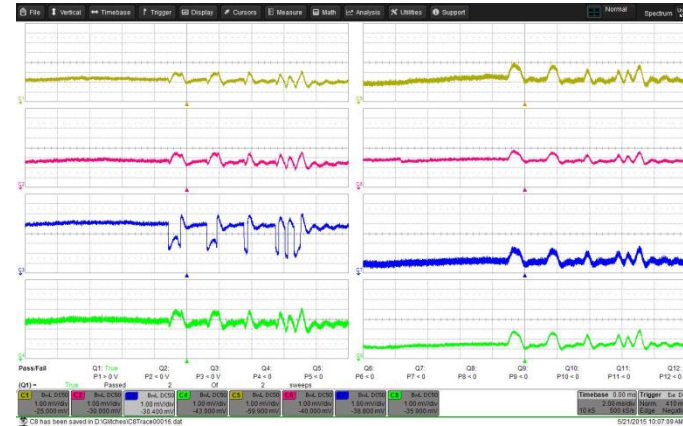
Beam Glitches and IOTs

Beam is occasionally kicked by tens of microns – could be a problem for MPS interlock

Beam kicks correlate with changes in combiner reject power

One IOT steps output by ~1%, all others react through LLRF

- Common voltage to all four IOTs in one amplifier – no individual IOT voltage steps
- Drive amplifier power remains constant – fault is at the IOT
- Effect vanished when all IOTs were transferred at cavity change – not a tube fault
- Appears to be a power supply issue
 - Grid bias voltage supply is the most likely candidate
 - Plan to test bias voltage stability with HVPS at zero voltage

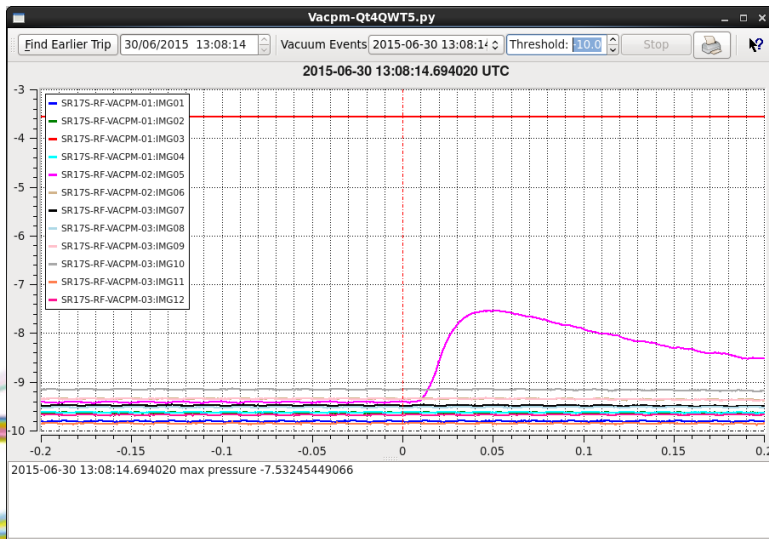
Stub 3 in

- Cavity 4 trip problem was cured by reducing voltage from 1.0MV to 0.8MV
 - Some loss of beam lifetime but interlock levels were cleared
 - Required change in 3-stub tuner position to maintain good coupling
- As a test, a beam trip was provoked by overloading cavity with the two 3-stub tuner configurations
 - Followed same procedure in both cases

Pressure profiles correspond to standing wave pattern and do not signify different processes

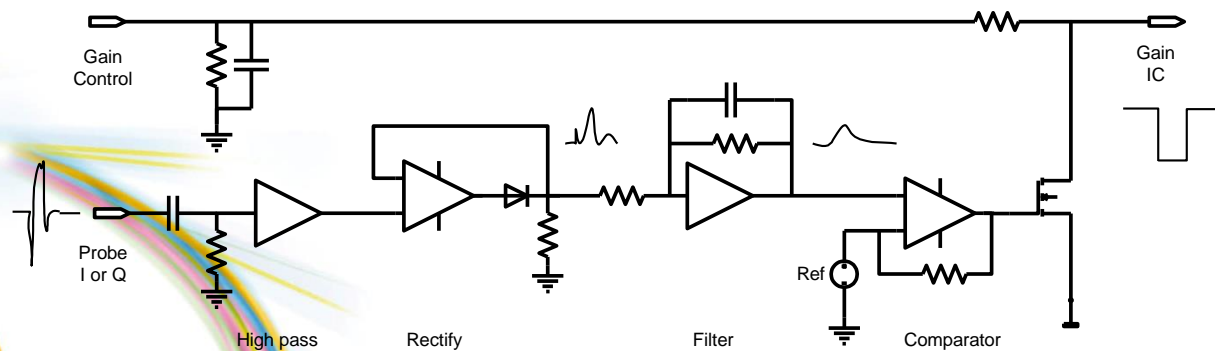
Simplified schematic of probe blip detection circuit

- fast rise-time spikes causing loss of RF signal on cavity HF pickup (and spare probes). Up to 4 blips/day/probe.
- LLRF interprets this as reduction in cavity volts and pushes up the forward power to compensate, causing a beam trip in some circumstances.

- Addition of filtering in the LLRF to reduce the bandwidth from 1MHz to 50 kHz. This has been successful at preventing trips at low loop gains. No probe blip trips since January 2014.
- Trial of a additional circuitry to detect the blip and reduce the loop gain during the period of the blip (~2 to 6 μ s typically).
