**SOLARIS**  
NATIONAL SYNCHROTRON  
RADIATION CENTRE

# Status of SOLARIS

**Paweł Borowiec**  
*On behalf of Solaris Team*

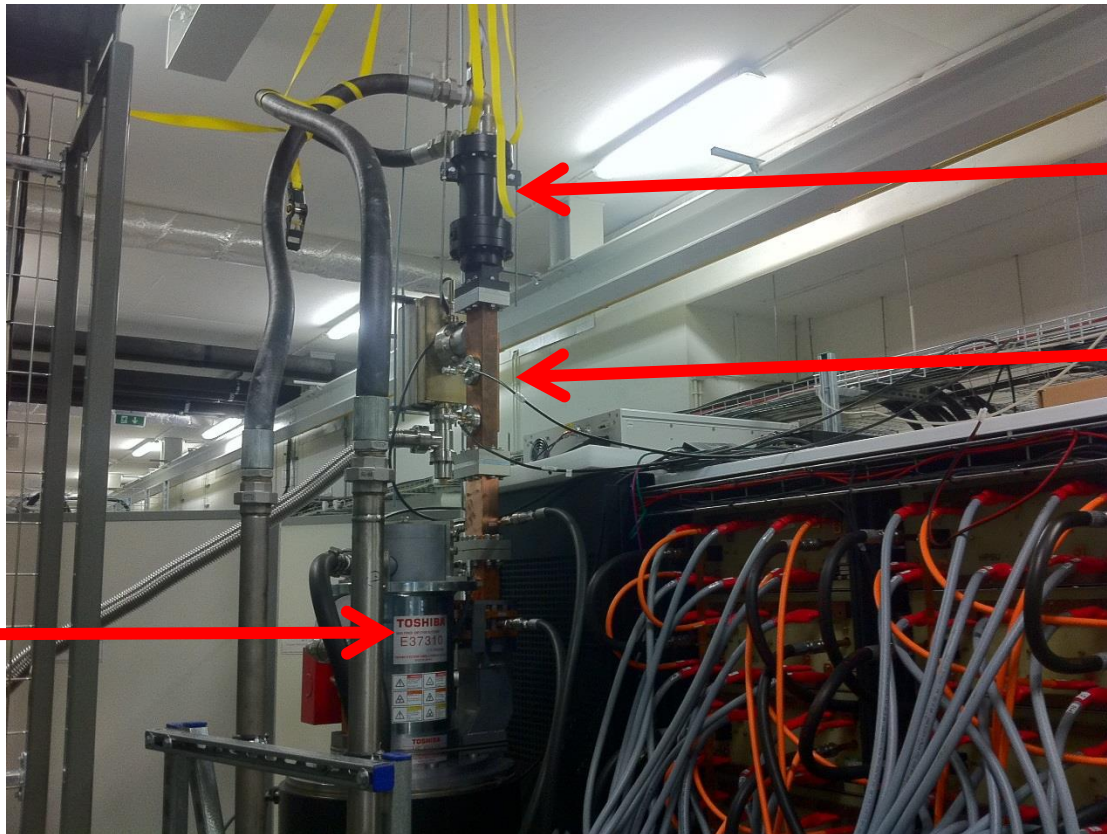
One K2 modulator driven up to 33MW on dummy load

Water cooled waveguide  
dummy load

waveguide directional  
coupler

klystron

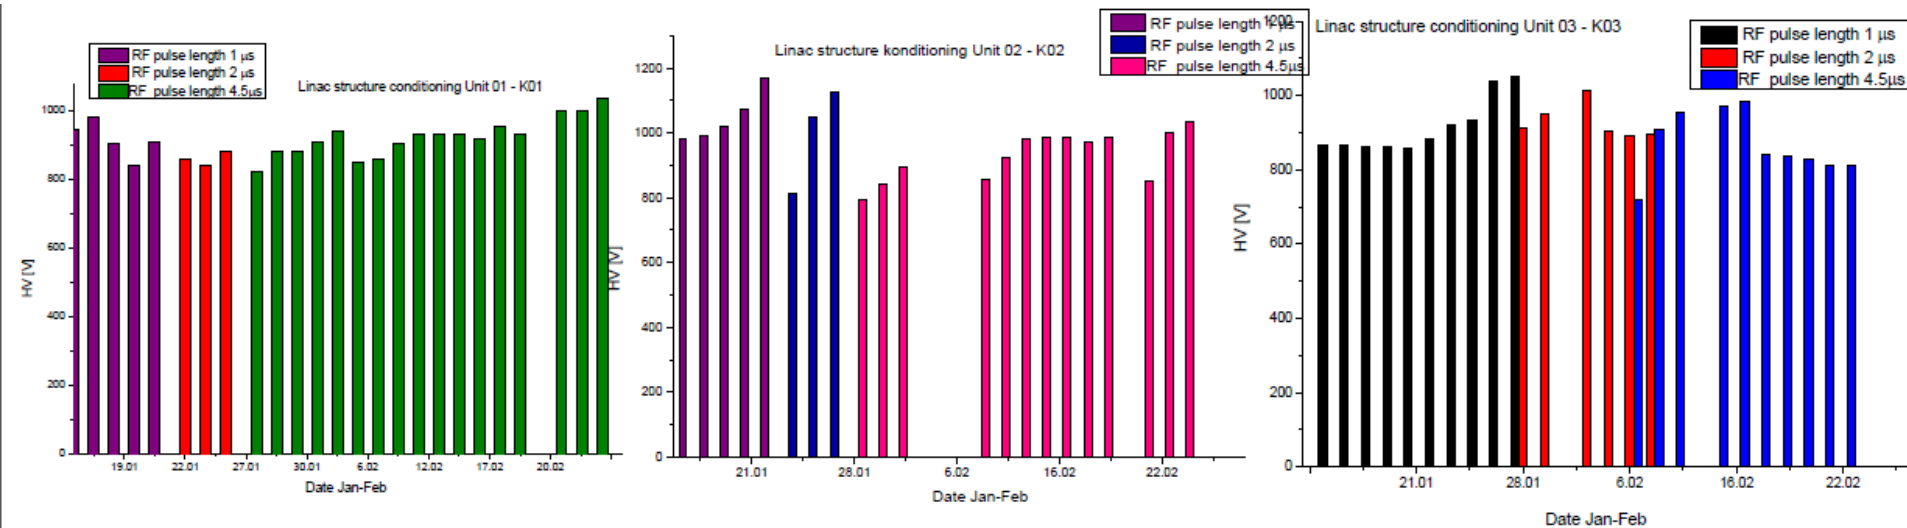
## January - February 2015

**Shifts organisation for linac conditioning (January- February & May-June):**

**Monday -Friday; 7 a.m. – 9 p.m.**

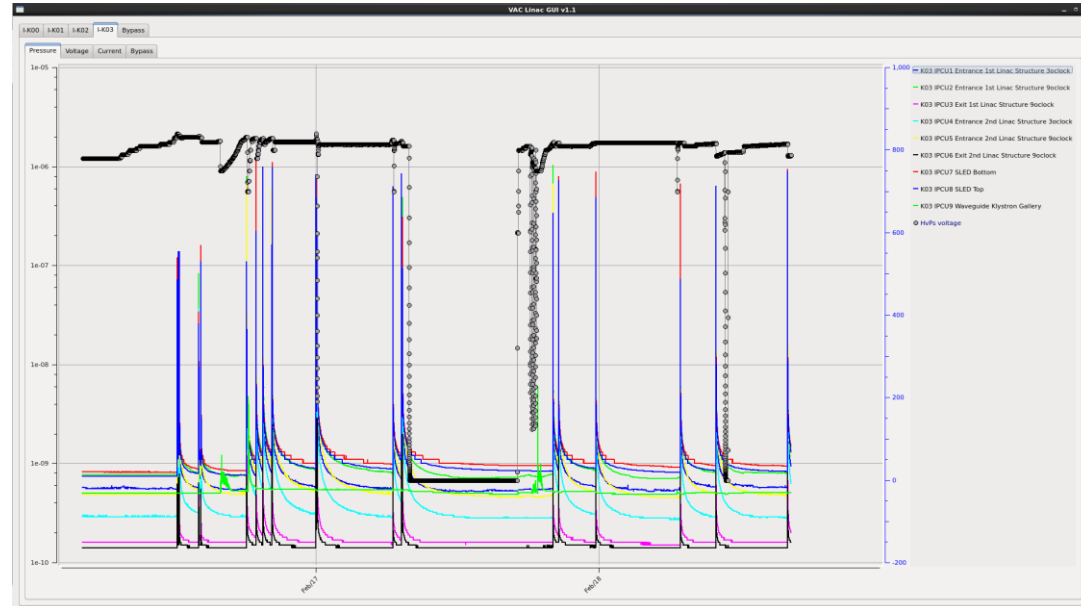
### Arcing in waveguides

- Broken 9 pieces of 20dB attenuators and 2 RF sensor diodes
- Still many vacuum activation at high power

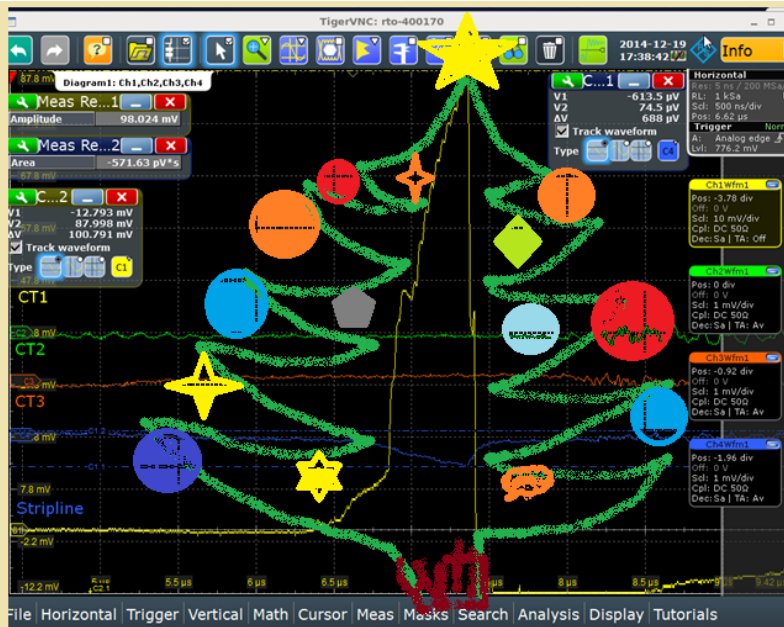
**First electrons from  
SOLARIS RF GUN**

**RF Power Forward to the  
gun= 0.86MW**

**Electron current = 100mA**

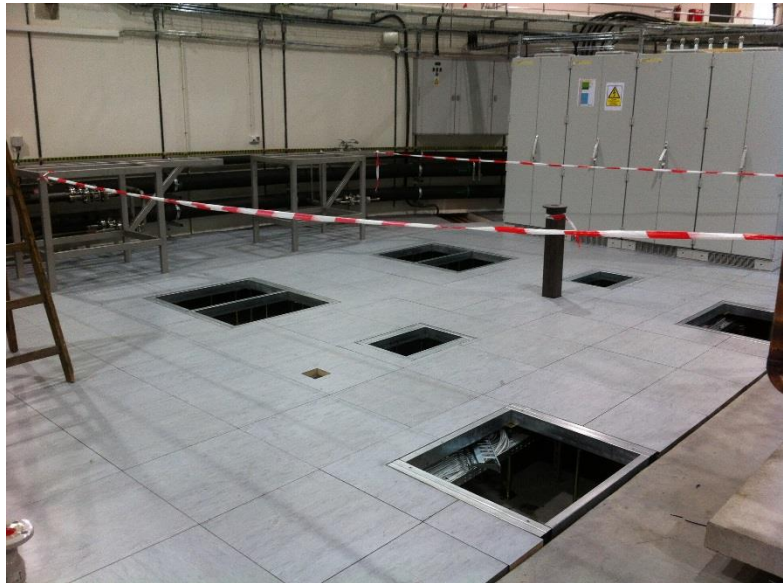
**High power SR RF installed and tested within 5 weeks  
10.03.2015 to 17.04.2015**

1. **Modification of raised floor, electrical grid in service galery 02.2015**
2. **Signature of contract with Rhode&Schwarz, Sweden in December due to formal reason with delivery date 10.03.2015**
  - **SAT of transmitters 23 - 27.03.2015**
  - **First THR9 system and highest installed RF power in Band II in Poland**
3. **Signature of contract with Rhode&Schwarz Poland for installation of transmitters and assistance during SAT**
  - **16 - 20.03.2015**
4. **Signature of contract with Exir, Sweden for installation of rigid line and assistance during SAT of circulators**
  - **Connection of transmitters to circulators with rigid line 07.04.2015**
  - **Connection of circulators to cavities with rigid line 15-17.04.2015**
5. **SAT of circulators 08 - 10.04.2015. AFT required to fix SAT date 8 weeks in advance**

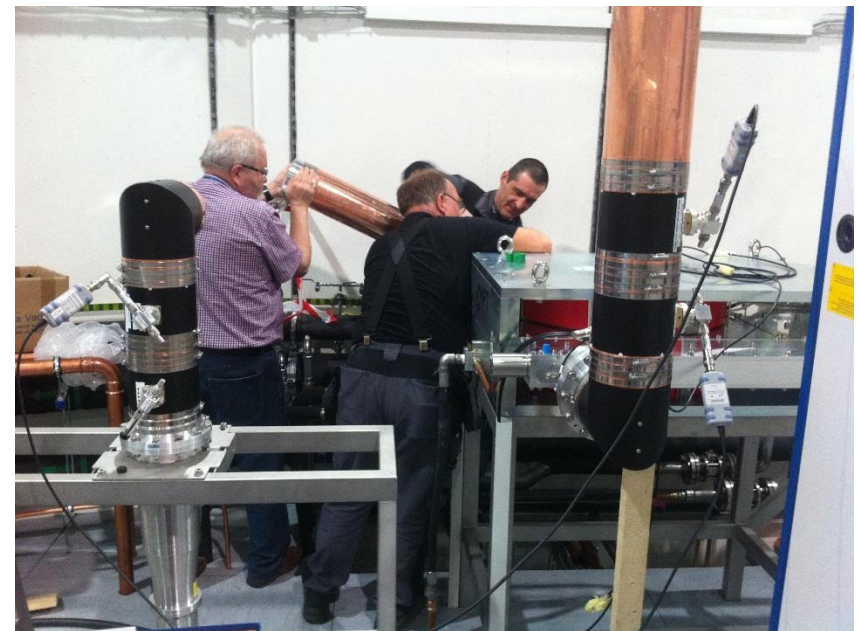
- Test at dummy load and  $0\lambda$ ,  $1/8\lambda$ ,  $1/4\lambda$ ,  $3/8\lambda$  terminations

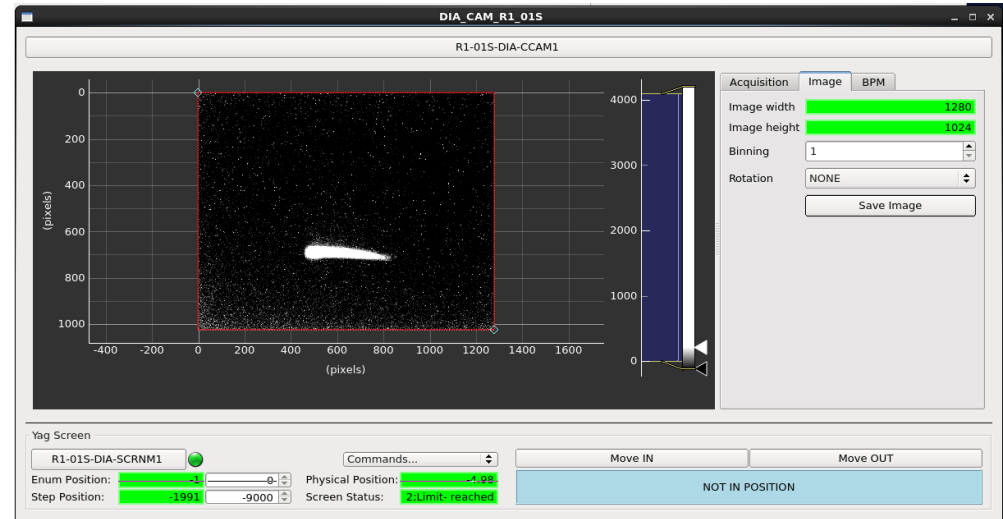
27.05.2015 first beam in storage ring,  
Energy 320 MeV  
Charge 1.5 nC  
Rep. rate 10Hz

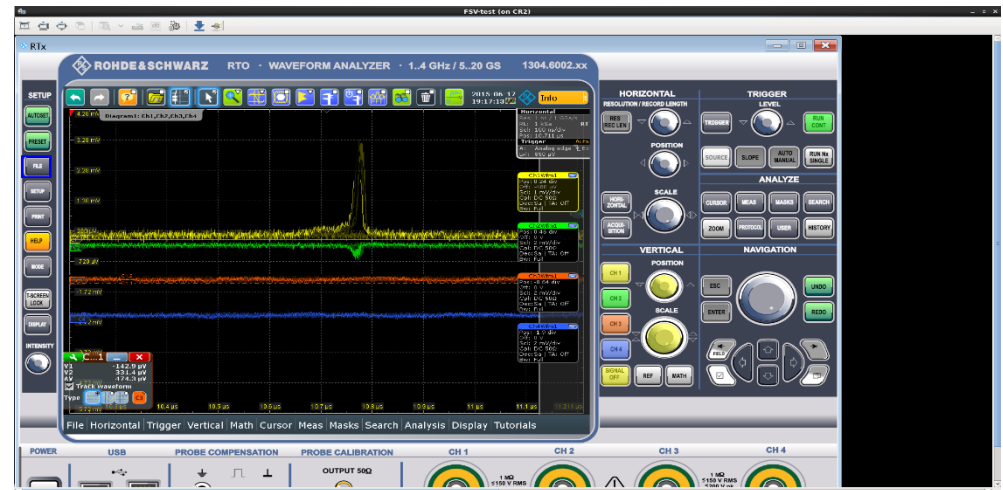
11.06.2015 first turn in storage ring  
stripline kicker connected  
to scope
