RF Progress at Diamond Light Source

Pengda Gu and Peter Marten
For DLS RF Group

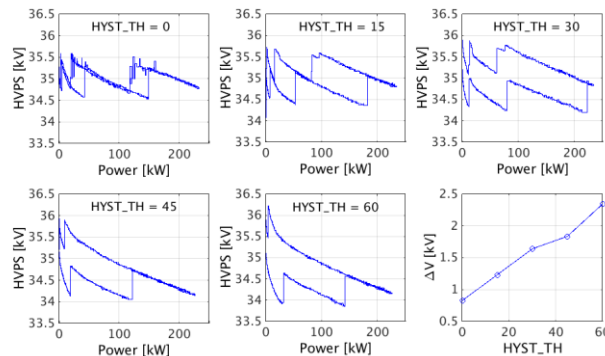
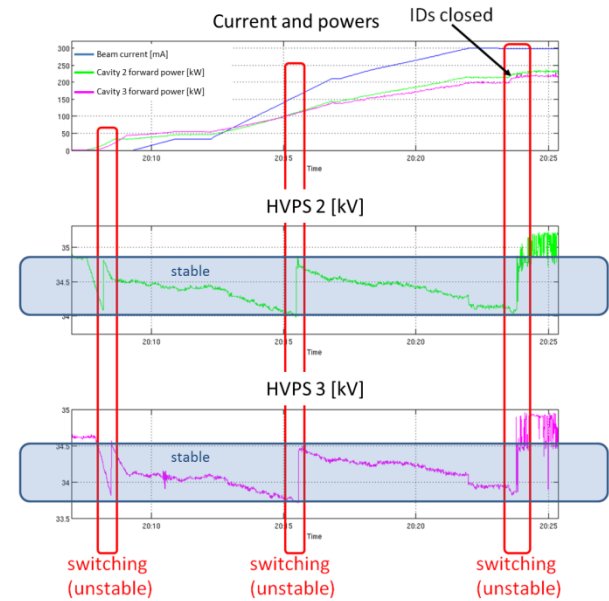
- Removing module PWM results in steps in IOT voltage which may cause global stability issues
- Must expand range of HVPS non-switching operation

- Firmware modified to introduce user-controlled dead-band to HVPS switching
- Global stability is ensured over the complete range of Diamond operation

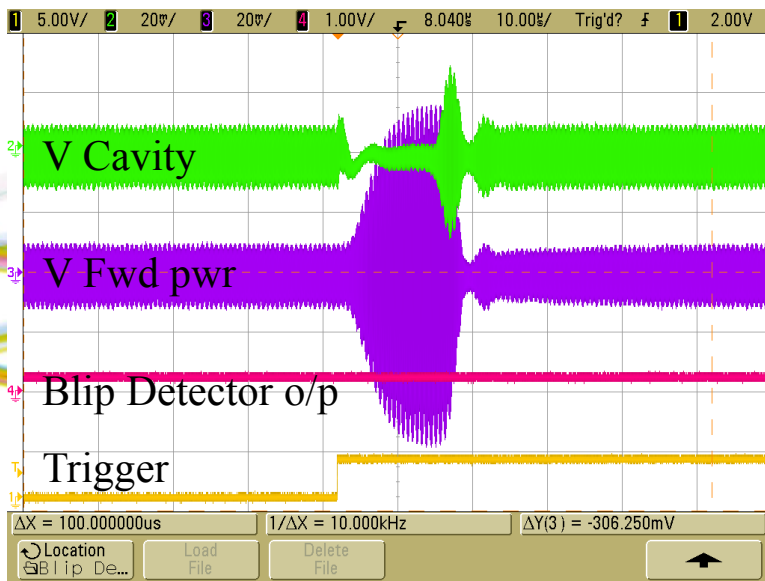
Circuit disabled

Tests using cavity simulator and blip simulated by blanking probe signal for 10us:

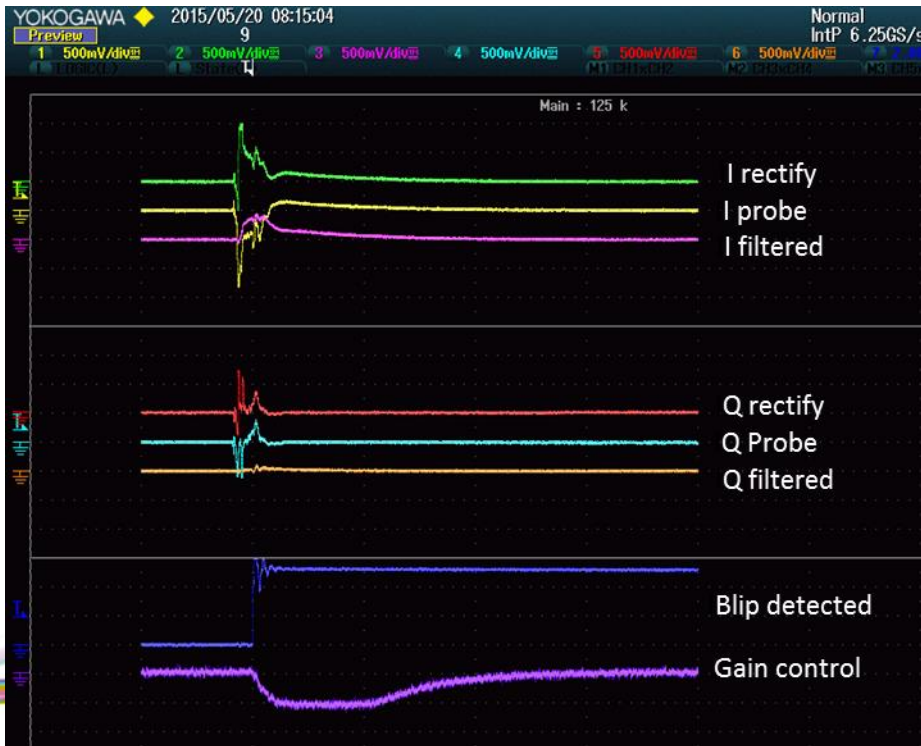
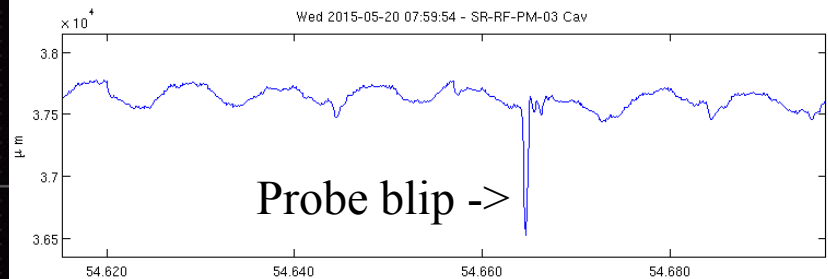
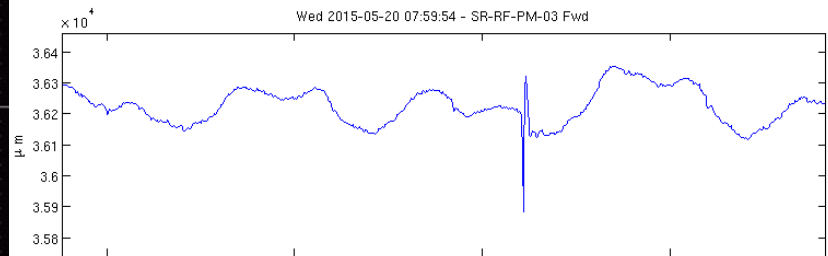
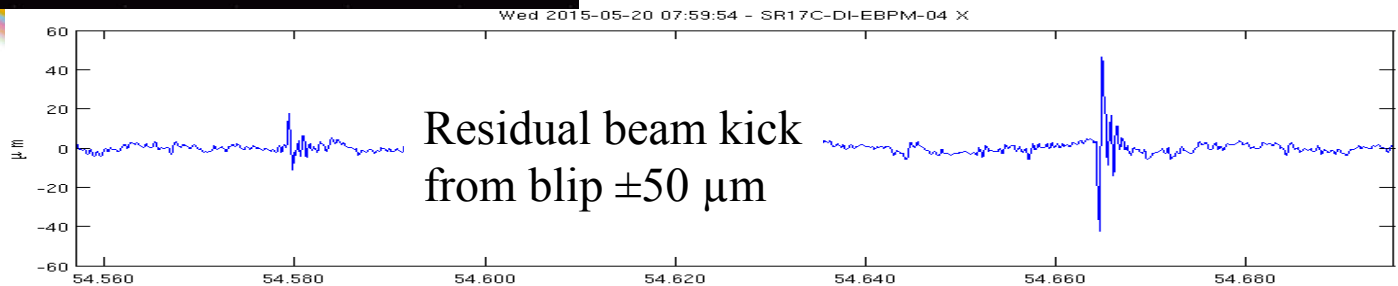
Storage ring tests @ 300mA with LLRF#3 modified to include blip circuit:

LIBERA box, Cavity , PFwd and beam (X) motion signals:

Attack and decay time-constants of gain reduction need optimisation to minimise beam disturbance.
