Status and Operation of the ALBA RF System

Jesús Ocampo, on behalf of the ALBA RF group:

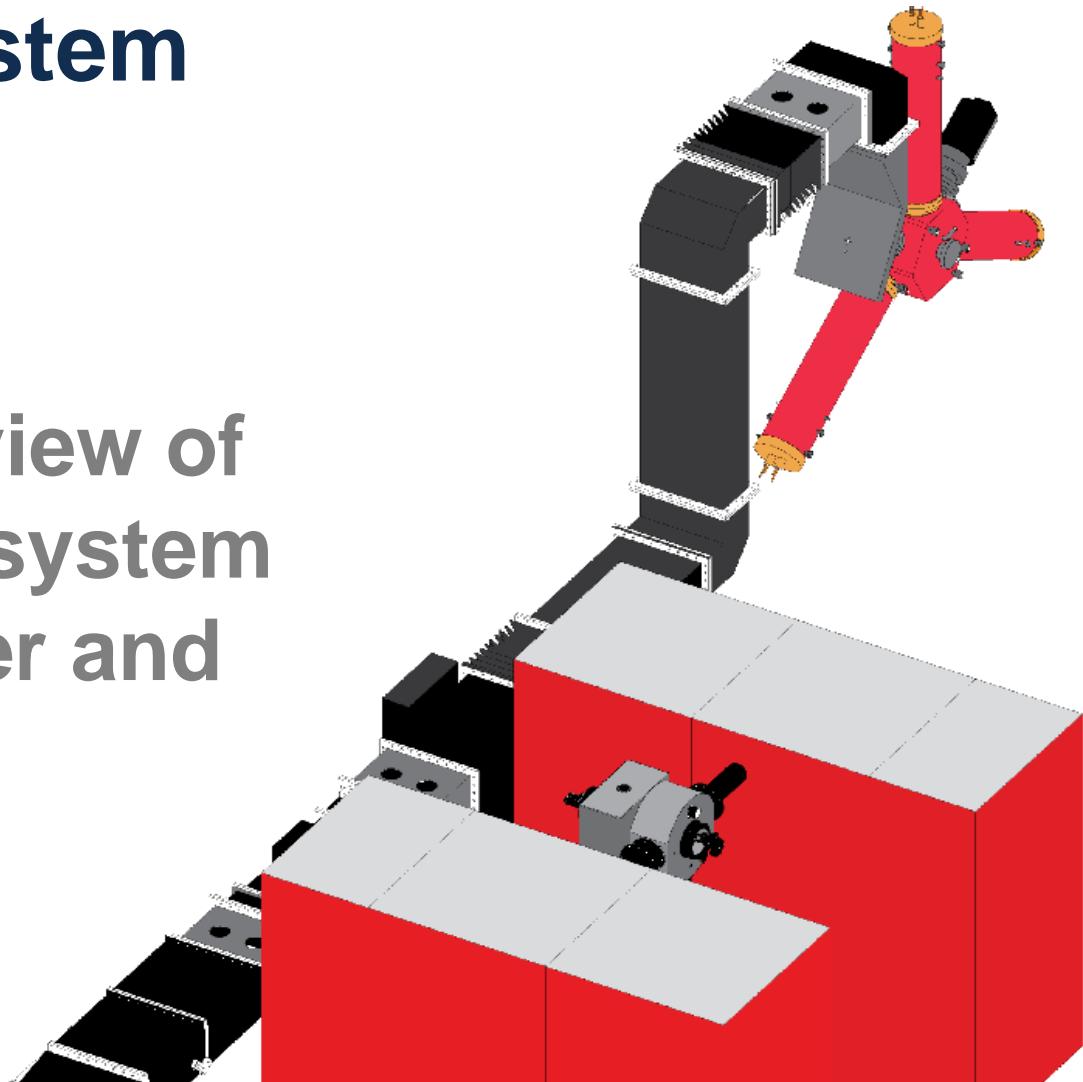
General overview of
the ALBA RF system
for the Booster and
Storage Ring

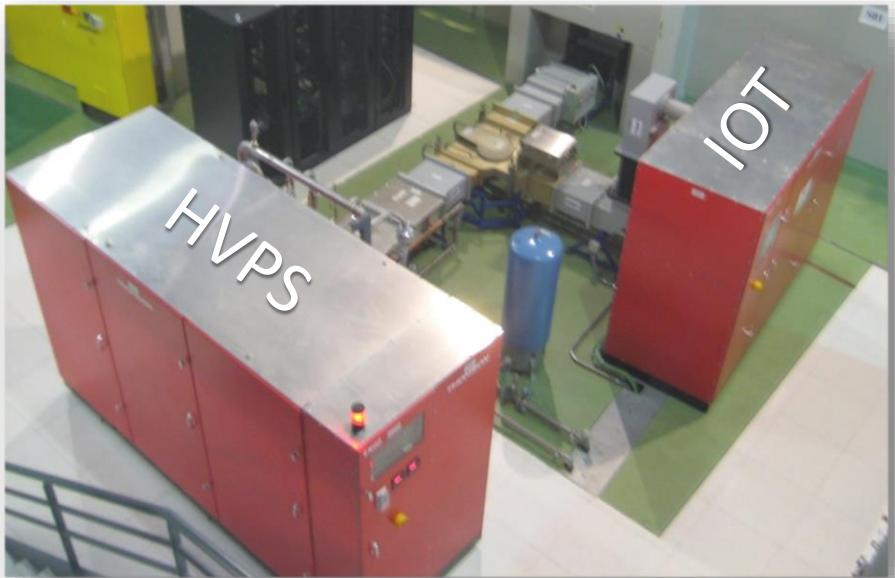
Service area:
80kW IOT amplifier

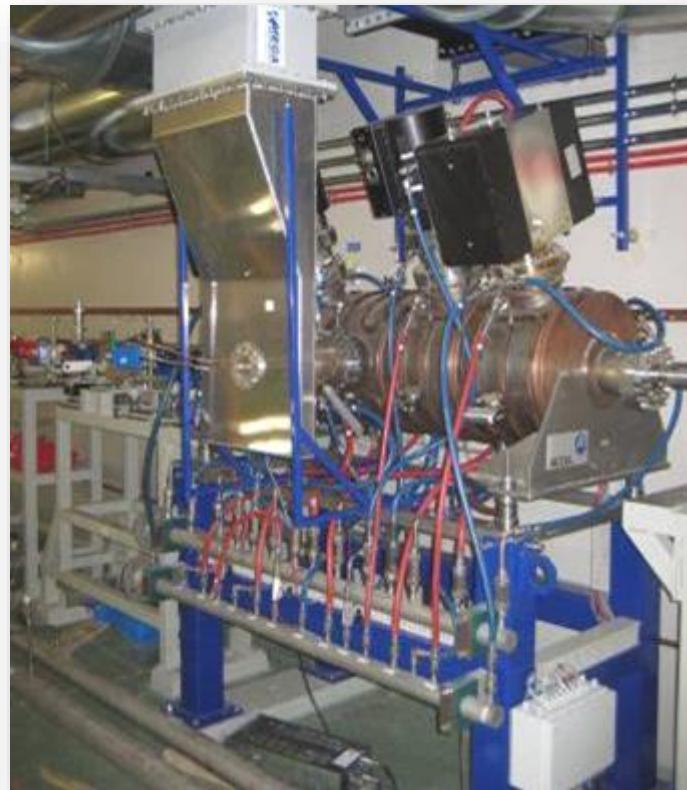
Tunnel:
5 Cell PETRA Cavity 500MHz

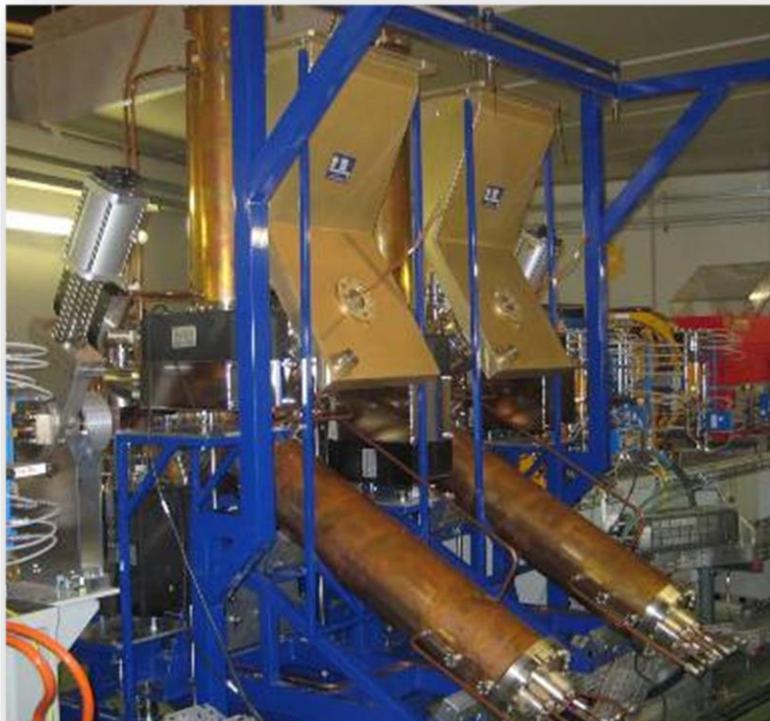
Tunnel: Dampy cavities
single cell – 500MHz

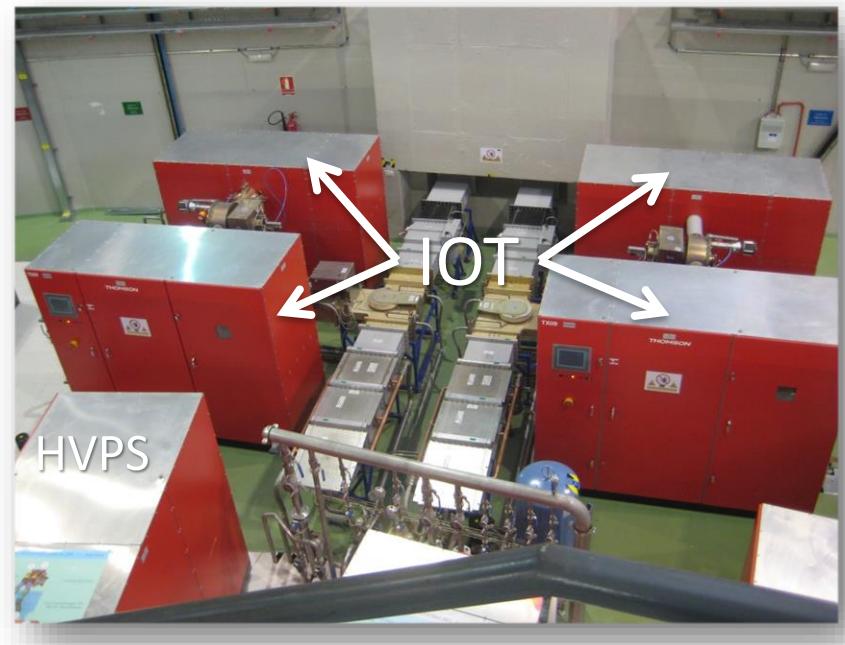
Service area:
2 80kW IOT amplifiers/cavity

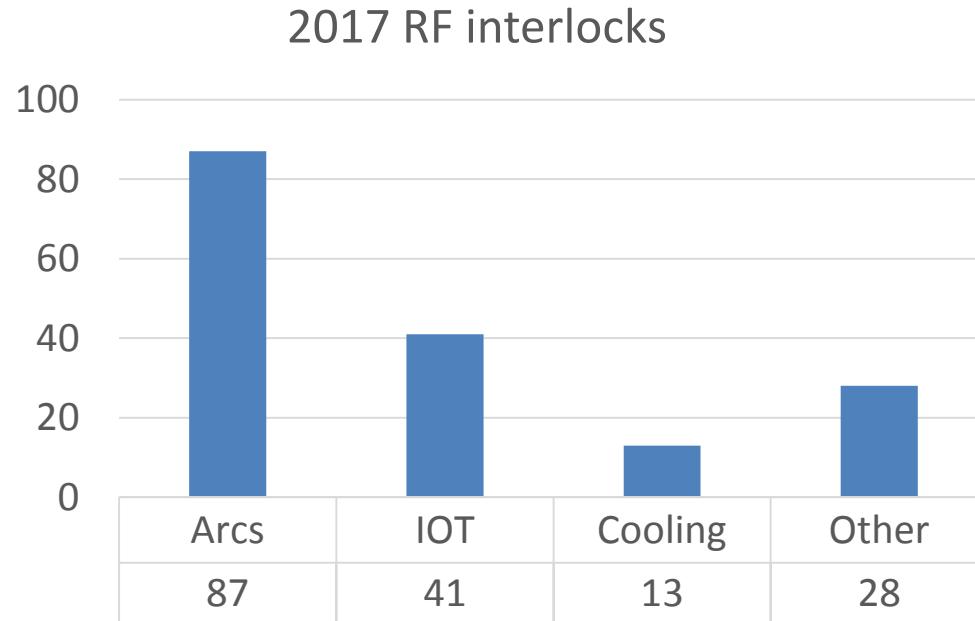
Operation mode: Top-up 150mA → 200mA (since October)
450kV/cavity → 500kV/cavity

Total: 169 interlocks
Only 13 beam losses (7,7%)
8,3 hours downtime (0,2%)

75% of cavity arcs after increasing voltage from 450kV to 500kV
75% of IOT interlocks in newly installed L3 IOT's. They disappear in ~ 2 months

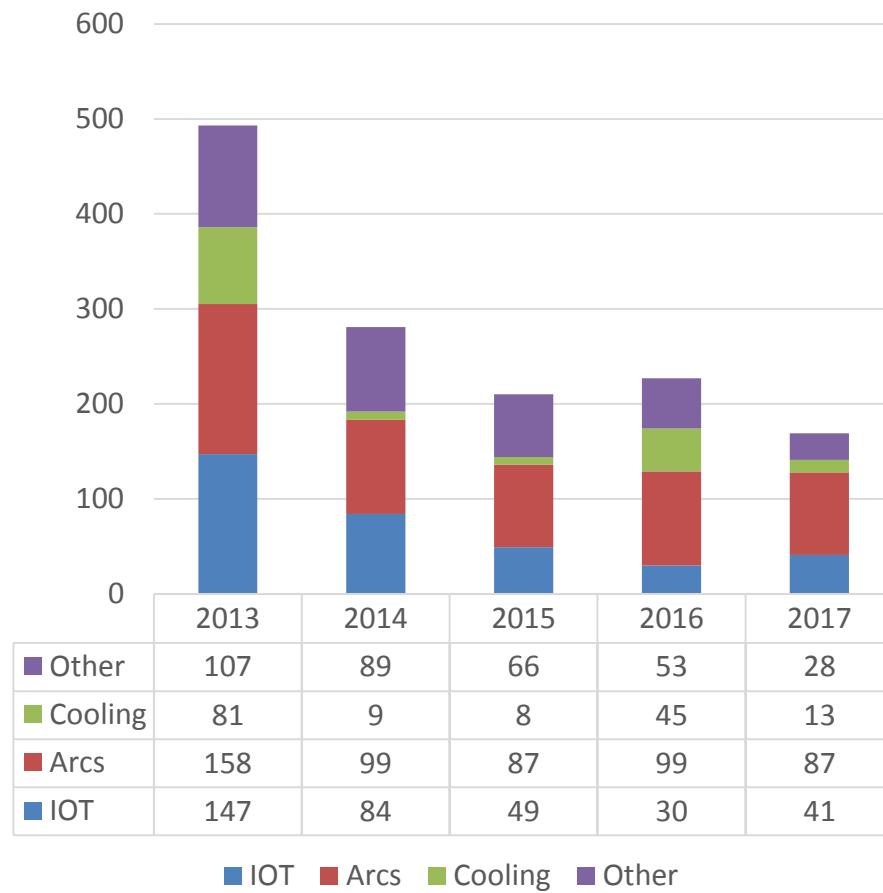
RF interlocks

Cooling interlocks greatly reduced

IOT interlocks similar to last year, even though 6 new IOT's have been installed

Arc interlocks similar to last year, despite the voltage and beam current increase

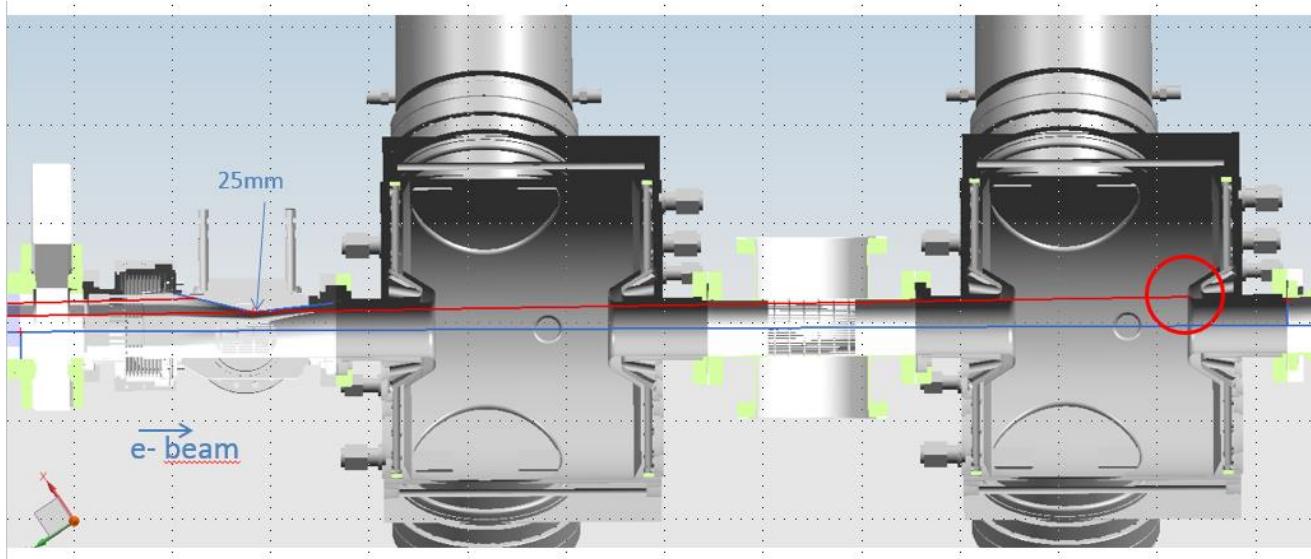
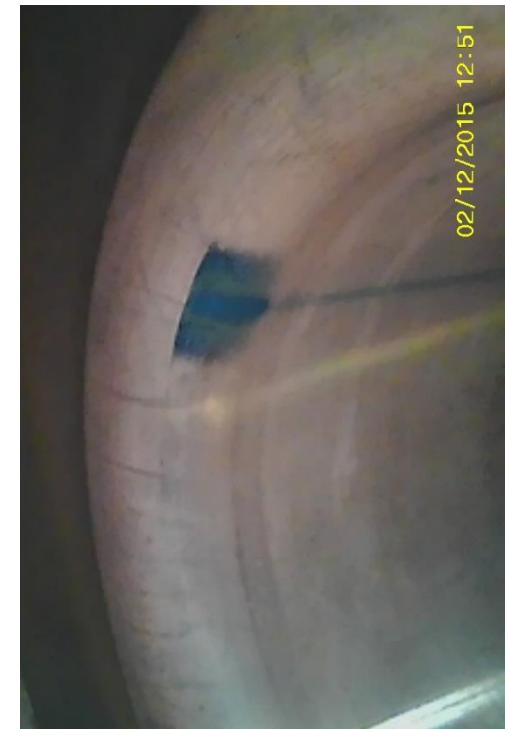
06B cavity arching solved

- Cavity opened in January 2016
 - Marks of synchrotron radiation impact in the nose cone
 - Ray tracing shows the origin: radiation from the previous bending magnet not blocked by the absorber
- Absorber replaced
 - Interlock number now on par to other cavities

Ray tracing courtesy of R. Monge (Vacuum group)

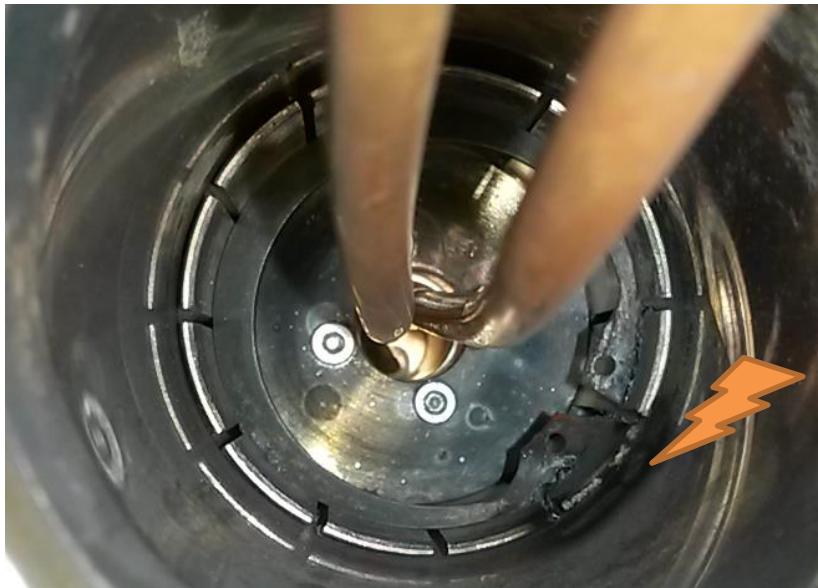
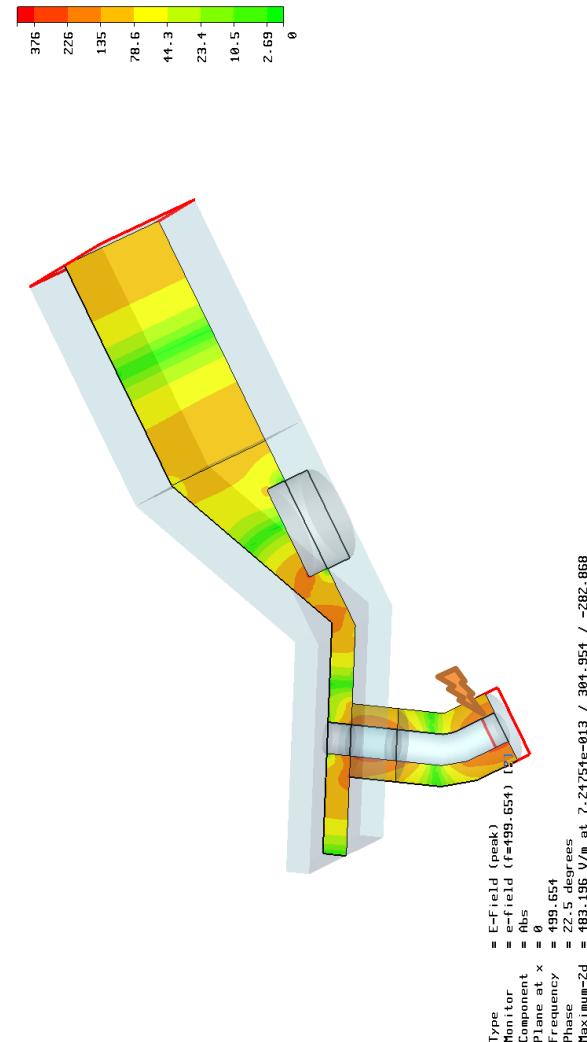
- 6 arcs during one night
- Coaxial WG Circ Clip damaged

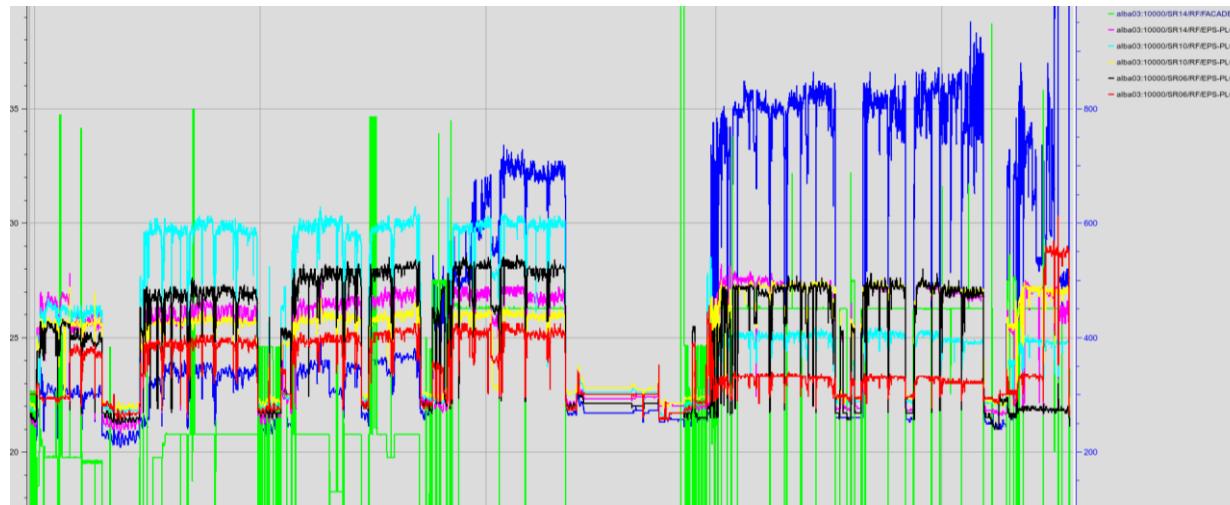
- New coaxial WG made by Rymsa and currently in operation
- Later analysis
 - Cooling air temperature of coaxial part (blue) increased from 25° to 35° in the last months

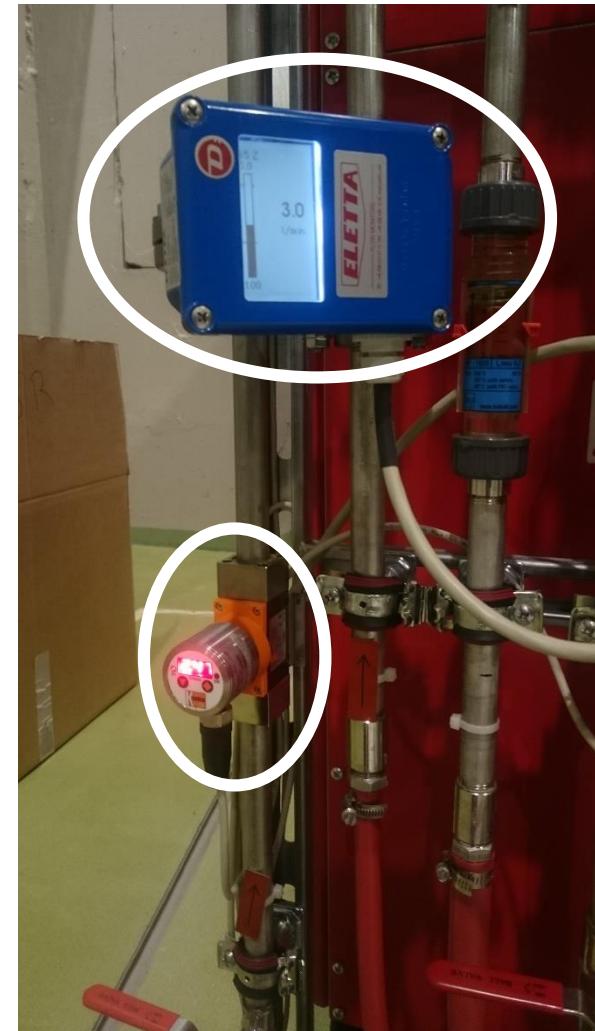
Cooling interlocks

- Fake cooling interlocks
 - Old WFM's sampling rate of 0,5s
 - Some samples are lost internally
 - A delay of 1s was not enough to prevent all fake interlocks
- New WFM no incidences so far
- Gradual replacement.

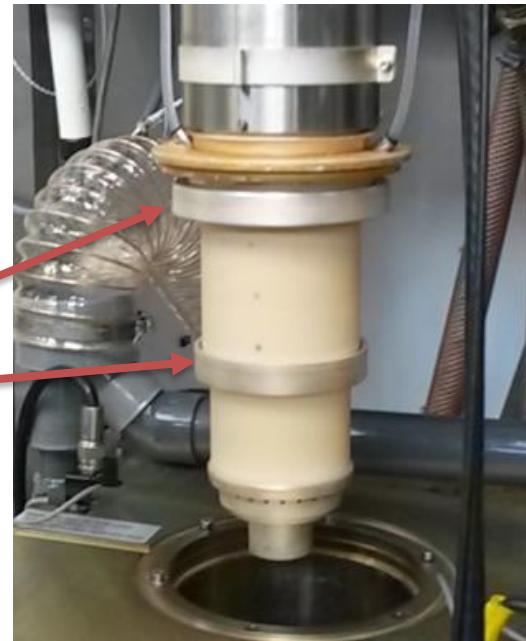
- Ceramic and gun: more reliable
- Adaptation kit needed
- +1MHz bandwidth tuning required, but gain is not compromised

TH795 with upper adaptation ring installed

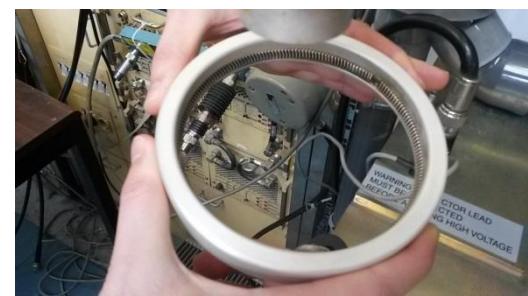
Lower ring of the adaptation kit

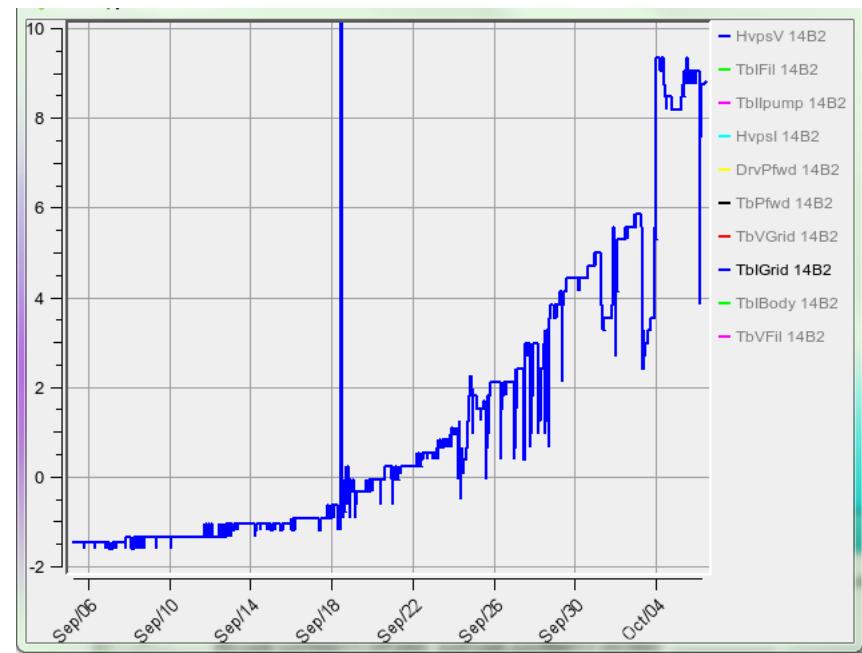
- 13 units received and successfully tested
- Modifications done to the first series made the operation more reliable
- Manage heater carefully to prevent grid emission

Grid emission in 100017 during first month

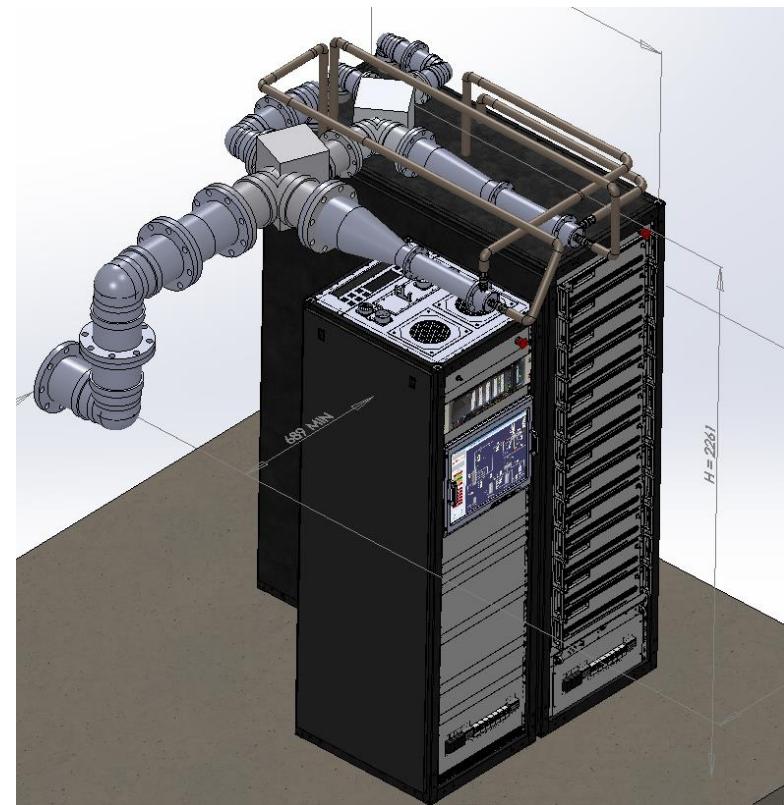
- Collaboration with CLIC to build a 1,5GHz RF system
 - Accelerating system in damping ring
 - 3rd harmonic system in ALBA
- Cavity design almost finished
 - See B.Bravo talk tomorrow
- 1,5GHz SSA module prototype
 - See Z. Hazami talk tomorrow
